Manhole Inspection Summary

Manhole # S31II_012MH

Insp Date: **10/21/08 10:28 AM**

Location Address: **131 W. LAFAYETTE AVE**

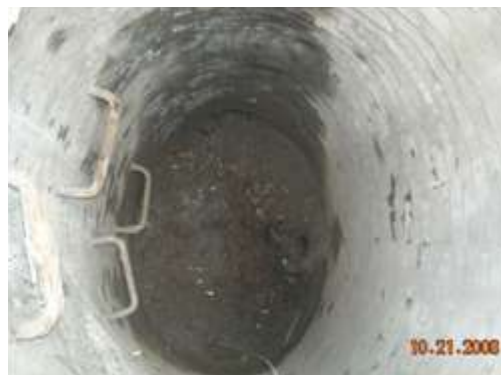
Top View

☒ **Debris** (not Condition related)

Count: **5** Missing: **0** ☒ **Corroded**

Corroded steps. Channel debris.

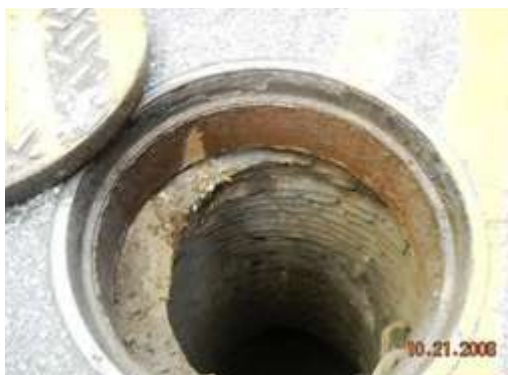
Defect

Subject To Ponding: **Sheeting**

INFLOW EVIDENCE FROM SHEETING

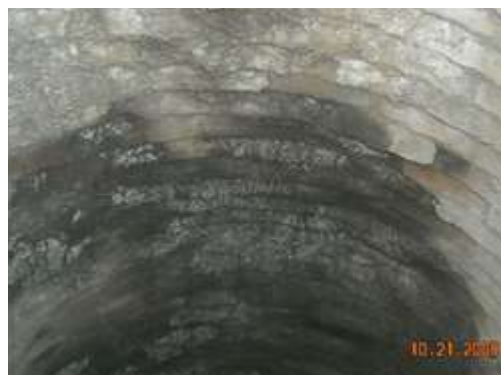
Defect

Infiltration: ☐ None ☐ Joint ☐ Cracks ☐ Mortar ☐ Roots ☒ **Wall**

Corbel and Barrel infiltration.

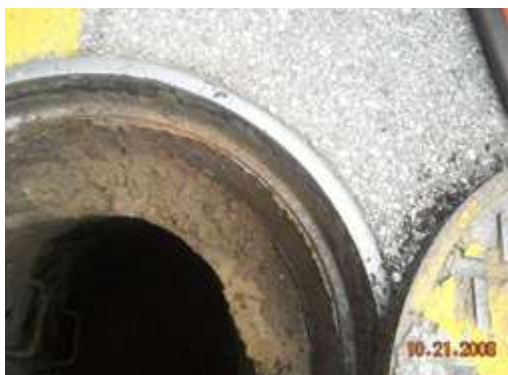
Defect

Offset: **3.5** (in.)

☒ **Leaks**

Infiltration: ☐ None ☒ **Joint** ☐ Cracks ☐ Mortar ☐ Roots ☒ **Wall**

Frame leaks. Frame offset. Adjustment infiltration.

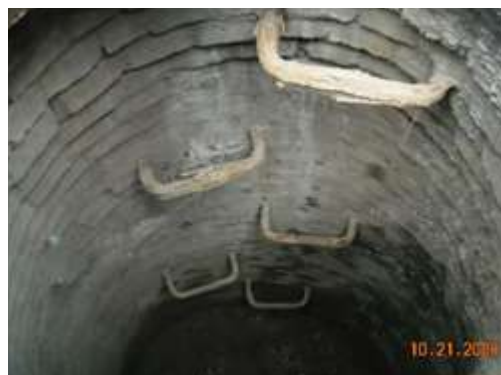
Defect

Adjustment, Corbel and Barrel infiltration.
